7 Things Every Playground Owner Should Know About the Accessibility of Their Playground Surfaces

A publication of the U.S. Access Board and the National Center on Accessibility

Surfacing the Accessible Playground:

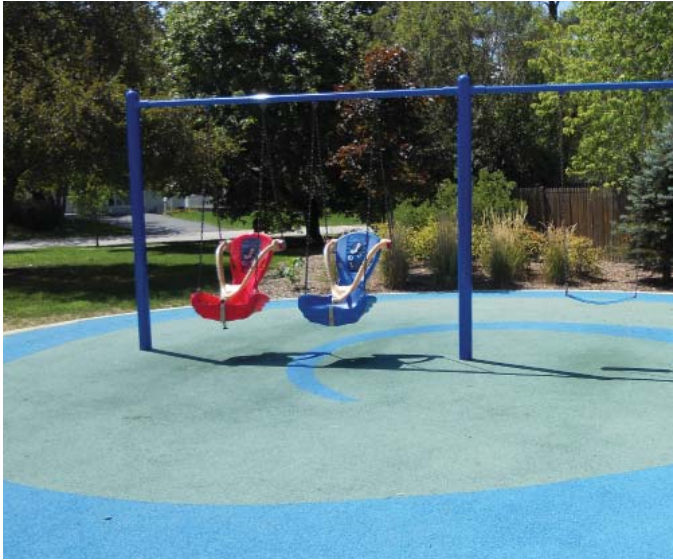
Poured in Place Rubber (PIP)

Wear layer with larger rubber particles and finished with a custom top layer of granular particles. A binding agent is used and the material is poured out on site or “in place” as it gets its name.

Cracking or flaking of the top layer can lead to divots and openings greater than 1/2 inch. Top layer deficiencies are often accelerated in high use areas (under swings, slides, teeter-totters). Results in non-compliant routes and clear ground spaces at equipment. May also result in non-compliant cross slope at entry/egress. Surface deficiencies can be traced to improper binding agent ratio, inability for product to properly cure, and deterioration of product over years of exposure to the elements.

Accessibility deficiencies at PIP sites were commonly found in areas where the granules from the top layer had started flaking off. This flaking condition has been linked to either inadequate ratio of bonding agent to granules when mixed on site; and/or failure of the bonding agent to properly cure when installed at 40 degrees Fahrenheit and falling. The manufacturer installation instructions show the preferred atmospheric temperature for installation to be 40 degrees Fahrenheit and rising. Left unattended over time, areas where the top granular layer has flaked away can lead to non-compliant clear ground space at play equipment such as swings, transfer systems and the egress of slides. Deficiencies related to installation methods may not become evident for months or even years. Thus, it is necessary for the playground owner to prepare for these situations prior to purchase through the terms of the warranty and/or specified funds for maintenance.

PIP was recorded as the surface material requiring the fewest instances of maintenance. Maintenance areas were noted where the surface had cracks, buckles, openings or a granular layer had worn away under high traffic areas like swings, transfer steps and the egress at slides. While PIP had the fewest instances requiring maintenance, it is still notable because the surface repairs can be extensive. Repairs must be done by either the original installer or professional certified by the manufacturer resulting in added costs. The patch repairs also necessitate cutting away a larger section of surfacing in order to fill and level the deficient area.

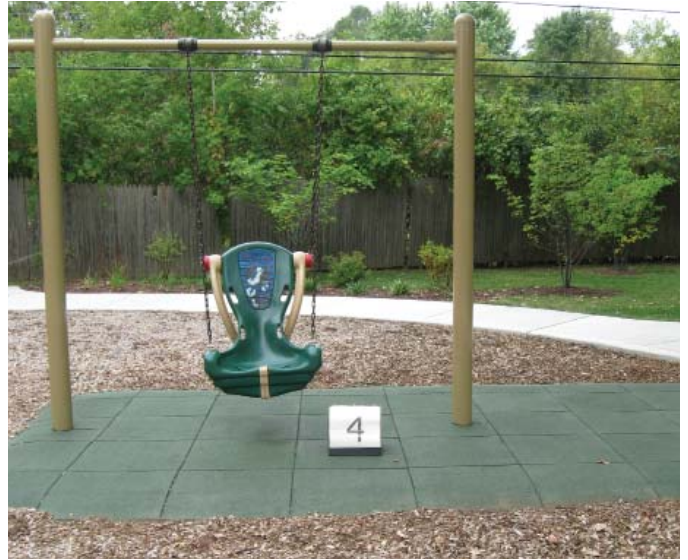
Tiles (TIL)

Puncture holes and shifting seams can create openings and changes in level along the accessible route and at clear ground space for equipment. Foreign particles can lodge in seams causing separation including lift from adhesive for subsurface. Instances of cracking may occur as the product ages. Settled or washed out subsurface may compromise structural integrity of individual tiles.

The NCA study identified accessibility deficiencies with TIL most often related to puncture holes ranging from .50 inches to more than 2 inches in diameter and locations where the seams had started to shift or buckle creating openings and changes in level along the accessible route. The puncture holes may be products of intentional vandalism or unintentional damage from users stepping on rocks and other foreign objects with enough force to penetrate the surface. Loose particles are also known for lodging in the TIL seams causing separation at the seams. Left unattended, the particles can lodge so deep in the seams that the adhesive can degrade and the TIL can separate from the concrete subsurface. As the product continues to age, instances of cracking have been identified where either the subsurface or structural integrity of the surface product is compromised. Because TIL are made from rubber product, the surface should

TIL sites were recorded with a high number of locations in need of maintenance. TIL deficiencies included punctures holes ranging from .50 inches to more than 2 inches in diameter; and instances where the seams had started to shift or buckle creating openings and changes in level along the accessible route. It was unclear whether the puncture holes were products of intentional vandalism or unintentional damage from users stepping on rocks and other foreign objects with enough force to penetrate the surface. Playground owners in the NCA study reported their maintenance crews were able to replace the TIL with puncture holes. Deficiencies were also identified at sites surfaced with a combination TIL and EWF. The intent of the playground design was to use the TIL as the primary accessible route to points of entry/egress and fill the remaining use zone with EWF. The loose fill particles of EWF were scattered throughout the play area, across the tiles, concrete walkway and in the grass. Some of the particles had started to lodge in the TIL seams causing separation at the seams. There were even instances where the particles had lodged so deep in the seams that the adhesive had degraded and the TIL had separated from the concrete subsurface. Over time, these areas would be identified with changes in level and openings requiring repair or replacement of the individual tiles.

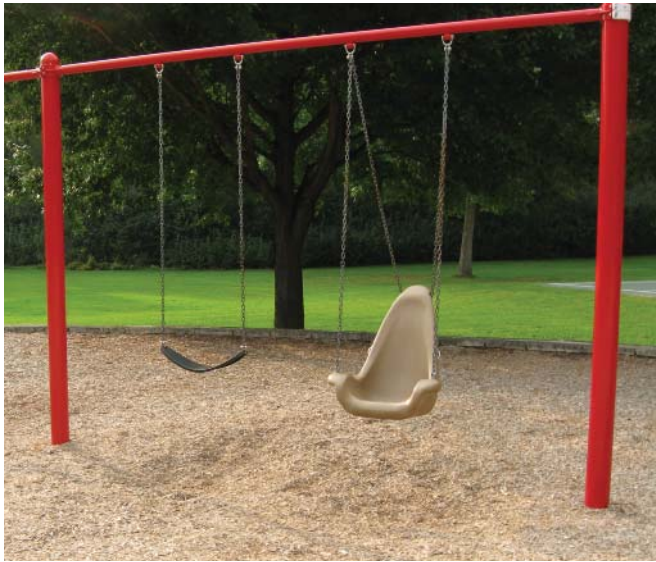
Engineered Wood Fiber (EWF)

ASTM defines EWF as processed wood ground to a fibrous consistency, randomly sized, approximately 10 times longer than wide with a maximum length of 2 inches. Free of hazardous substances. Not to be confused with wood chips.

Improper installation and/or maintenance can result in undulation across the horizon of the surface affecting running slope, cross slope and change in level. Product material should be installed in layers and compacted in order to achieve an accessible route and level clear ground space at equipment. Surface material is likely to displace at heavy use areas with motion, such as at swings, slides, sliding poles, climbers, spinners and teeter totters. Displaced material should be raked level and compacted before additional fill is added.

Sites installed with EWF were found to have the highest number of accessibility deficiencies within the first year of installation. Because EWF is a loose fill surface, it is frequently observed with accessibility deficiencies related to running slope, cross slope and change in level. EWF has been observed with undulation across the horizon of the surface area. The undulating surface material creates changes in level, running and cross slopes exceeding the maximum allowable standards resulting in non-compliant accessible routes to play components. It is critical for the manufacturer/supplier and the playground owner to communicate the process for installation. In most instances it is necessary for the loose material to be installed in layers, watered and compacted in order to achieve an accessible route and level clear ground space at equipment. Some playground owners consider the installation of EWF as an opportunity to use volunteers to assist in compaction by running drum roller teams across the surface area.

Loose fill materials, like EWF, may experience undulation of the surface material and or displacement under heavy use areas with motion such as at swings, slides, sliding pools, climbers, spinners and teeter totters. This will require the surface material to be raked level, filled and compacted so that the clear ground space is level in all directions for a safe transfer onto and off the equipment.

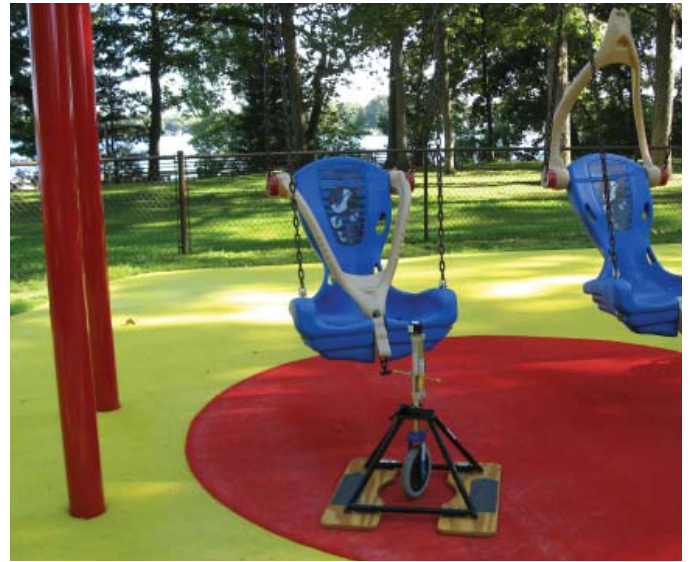
Hybrid Surface Systems (HYB)

Multi-layer system where the base layer may consist of either contained or loose particles like shredded rubber or carpet pad. The top layers may be outdoor carpeting, artificial turf, or rubber top mat.

Seams may separate or detach from the border creating changes in level and openings affecting the accessible route. Shifting of loose fill in the base layer may affect running and cross slopes. The artificial turf top layer may experience build-up of static electricity requiring application of anti-static solution.

Two of the three different types of HYB systems (outdoor carpet and artificial grass) were installed by contractors representing the manufacturers. These surface systems required installers experienced with laying the sub-surface, adjoining seams, and affixing the surface material to the border. Separation at the seams appeared to be the most prevalent concern following installation. Repairs to seams must be made by the contractor and costs are dependent upon the terms of the product warranty.

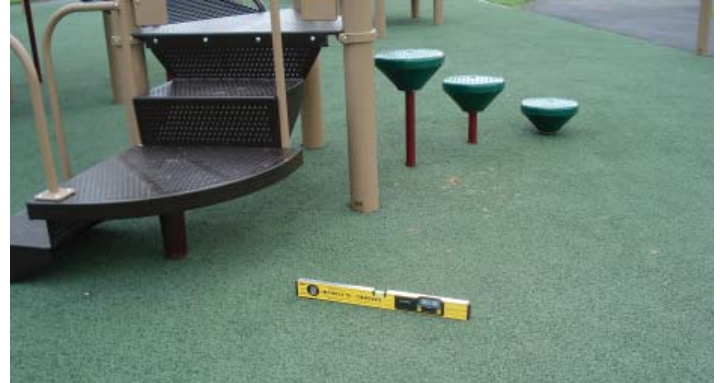
Measure the clear ground space in all directions with a digital level to ensure it is less than 1:48 or 2.08%. The clear ground space at all accessible play components entry and egress must be level for a child to transfer safely from a wheelchair to the play component.

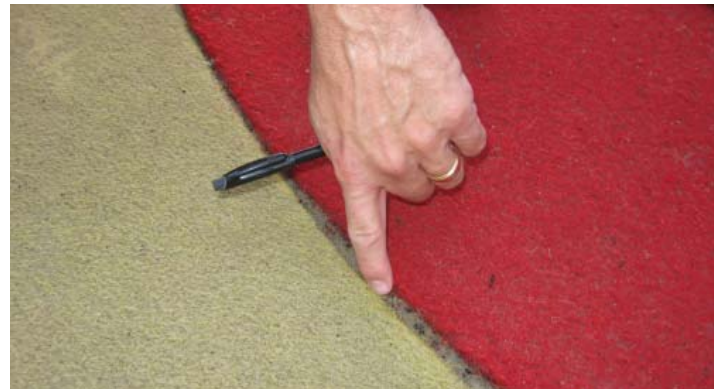
Openings or gaps in the surface cannot exceed a 1/2 inch.

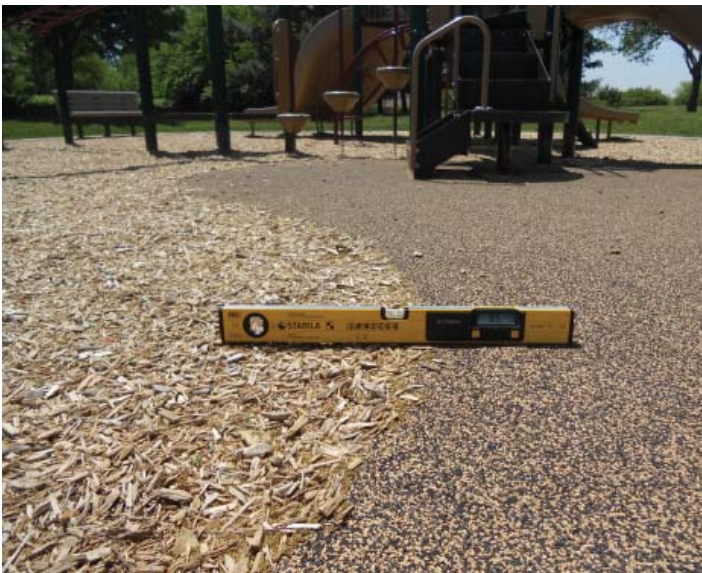
The maximum running slope for the ground level accessible route must not exceed 1:16 or 6.25%. Using a digital level is one option for measuring the slope of the ground level accessible route.

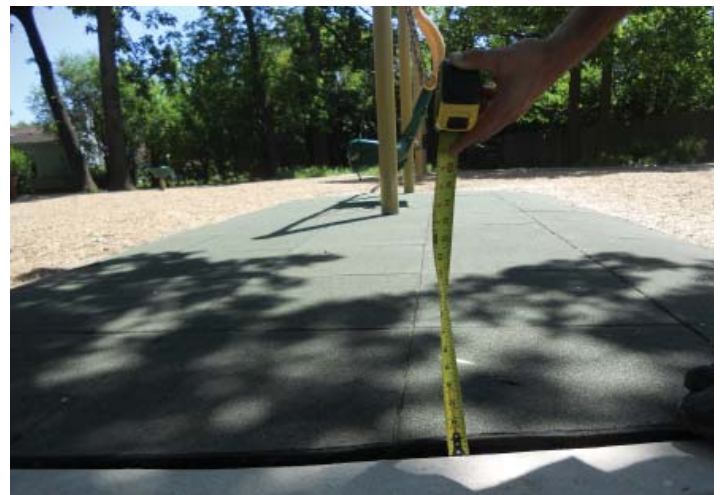
Check for changes in level, especially at transitions between surfaces. Changes in level from 1/4 inch to 1/2 inch must be beveled.

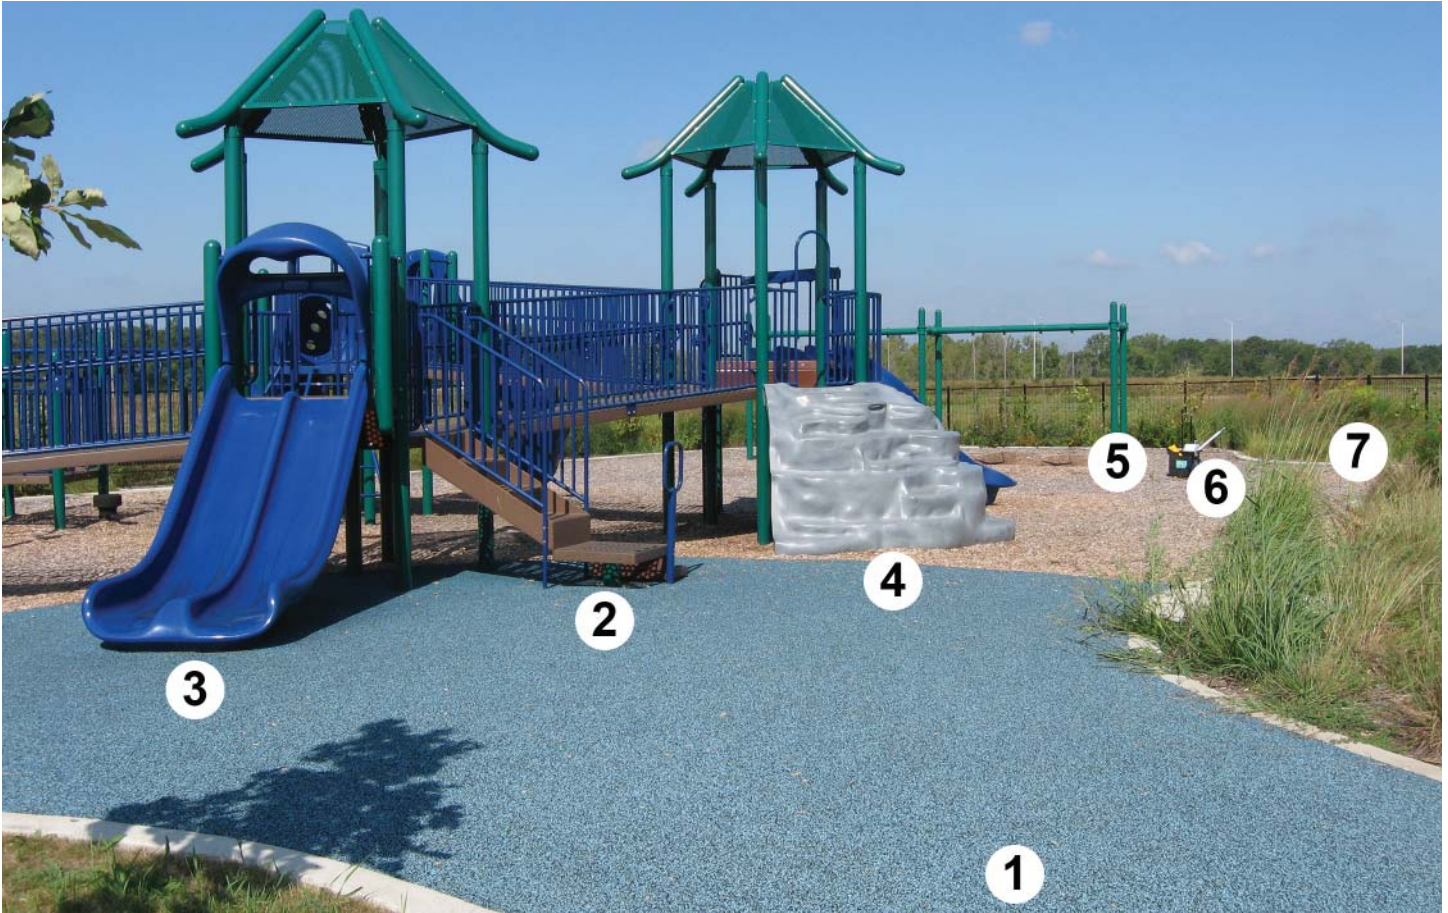
When conducting an assessment of the ground level accessible route, it helps to start with “the big picture” -- to view the play area in its entirety. Begin at the entry to the play area. Identify the accessible play components and the path to entry/egress for each piece of accessible equipment. Then focus in on the accessible route. Each segment of the route should be assessed for compliance with the accessibility standards. Look for the worst areas, those locations where the slope or cross slope may exceed the standard, where changes in level may be too high, or where openings may be too large.

One method to assess the ground level route using the photo above would be to look at each route segment, such as:

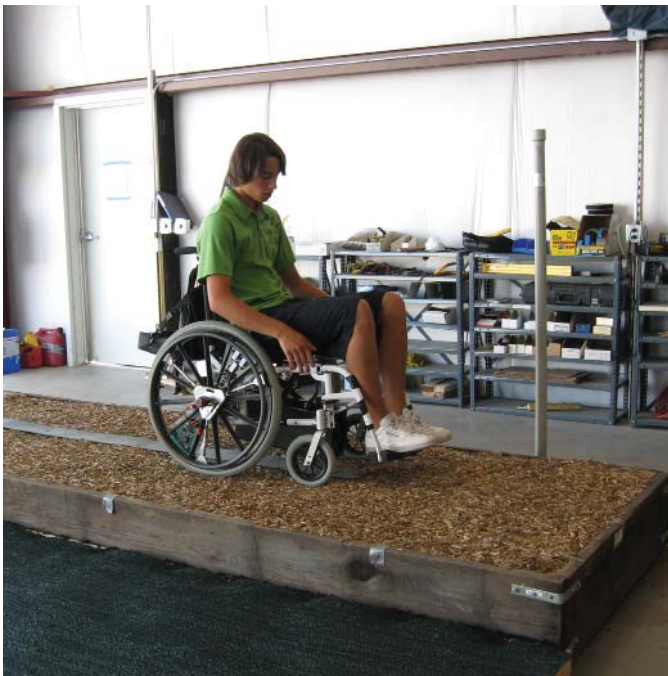
The "wheelchair test" is conducted on a sample test bed in the lab to determine the results for ASTM F1951-99.

This is a laboratory test measuring the work force required for a 165 (+11 or -4.4) lb. individual in a manual wheelchair to propel across a given surface.

The lab test uses a 7 percent ramp as a baseline for the wheelchair rider. After the baseline is established, the rider conducts a series of straight propulsions over the sample surface for a minimum distance of 6.56 ft. The force needed to propel the wheelchair rider over the surface is measured. A

second series of tests are then run where the wheelchair rider makes a 90 degree turn and the force is measured again. If the average work per foot for the sample surface is *less* than the work force to propel up the 7 percent ramp, the surface sample is considered as passing ASTM F1951-99. The advantage of the ASTM F1951-99 test procedure is that it provides a starting point to compare various surfaces by an objective measurement. However, the primary disadvantage and criticism of the protocol is that it is designed as a lab test in a controlled environment and cannot be easily replicated in the field or outdoors at multiple playground sites. Researchers have attempted to address the portability of this test protocol with the development of the Rotational Penetrometer (RP) described below.

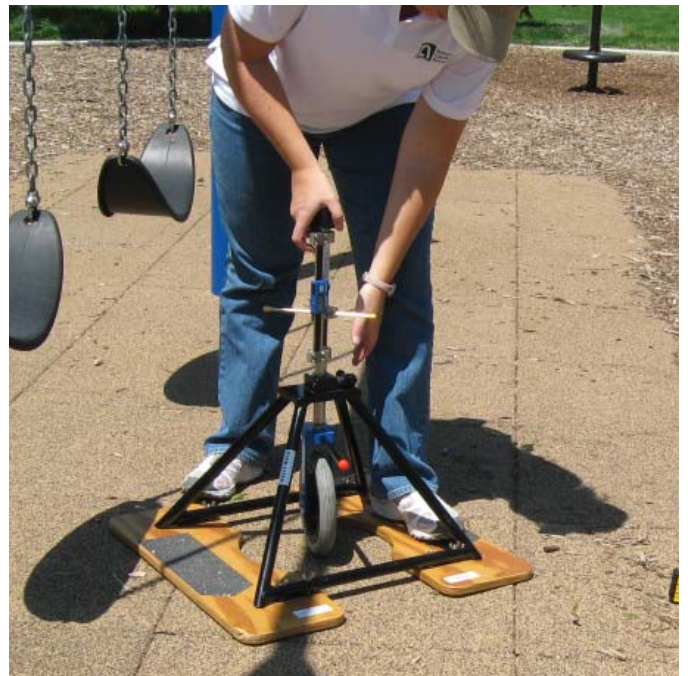
A Rotational Penetrometer (RP) is used here to measure the firmness and stability of the surfaces.

The RP design includes a wheelchair caster placed on a spring loaded caliber in a metal tripod frame which suspends the caster about 6 inches over the surface. When the caster is released, the spring load gauge replicates the force of an individual in a wheelchair over a given surface. The penetration into the surfaces is measured for readings of “firmness” and “stability.” National experts recognize the use of the Rotational Penetrometer as a portable and relatively easy device to use for surface testing. The field test method with the RP can be added to the assessment process just as measurements for slope, cross slope, change in level and openings are taken along segments of the accessible route for the play area. The RP can measure those segments for firmness and stability. This can be valuable in assessing how an installed surface performs over time.

While the ASTM F1951-99 protocol does not include a procedure for field testing outdoors at a playground, a field test method has been developed by the same engineering company that developed the original lab test method. A portable instrument known as a Rotational Penetrometer (RP) has been designed to measure the firmness and stability of surfaces. For the purpose of the NCA study, the Rotational Penetrometer was used as the field instrument to measure firmness and stability in lieu of the costly equipment for ASTM F1951-99. Documented research has shown the Rotational Penetrometer to have a high degree of repeatability and reproducibility (ASTM, May 27, 2005; ASTM, September 2010). These research findings also correlate to the lab test.

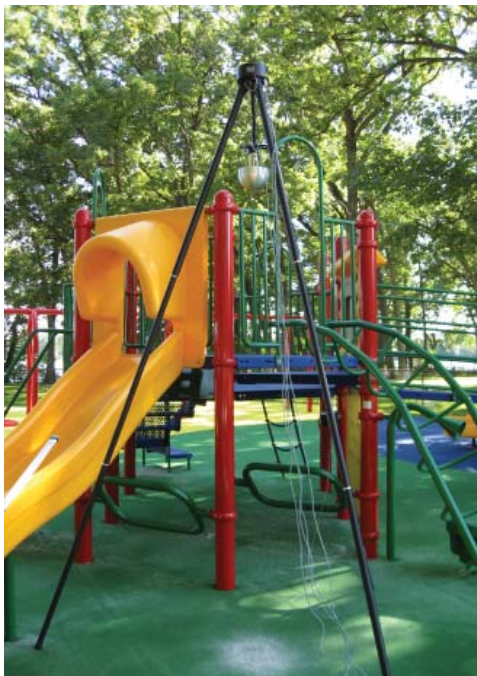
A TRIAX is used here to test impact attenuation or the play surface’s ability to absorb a fall and reduce severity of injury.

In the field, ASTM F1292-99/04 Standard Specification for Impact Attenuation of Surface Systems Under and Around Playground Equipment is also known as the “head drop test.” It is a test to make sure the surface is resilient enough to prevent a life-threatening injury from a fall. A 6 inch diameter aluminum hemisphere in the shape of a child’s head is dropped from the top of a tripod based on the fall height of play components. The aluminum hemisphere, or missile as it is called, contains an accelerometer. When dropped, the impact attenuation of the surface is measured in G-max and by the Head Injury Criteria (HIC). G-max is a measurement of the maximum acceleration, while HIC measures an integral of the acceleration time. The maximum values allowable by the standard are 200 for G-max and 1,000 for HIC. A TRIAX is the instrument used to conduct this test in the field.

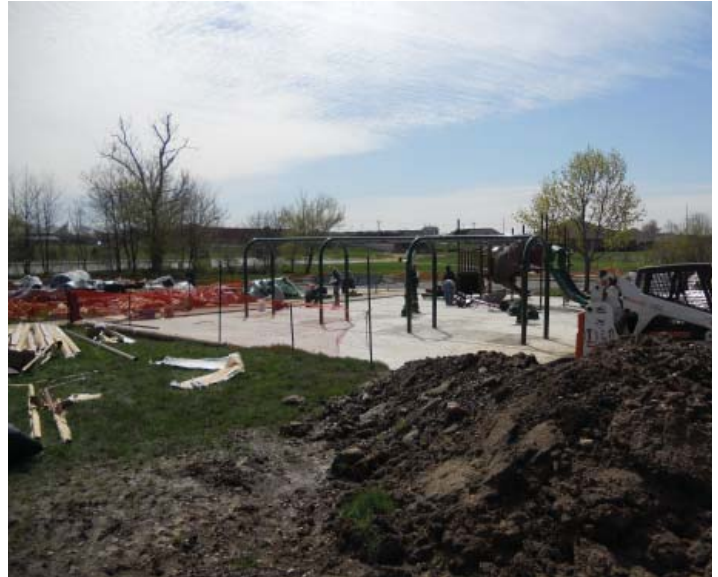
The playground site has been graded with earth-moving equipment. The concrete base has been prepared and is awaiting the application of the poured-in-place rubber (PIP) system. At this site, the playground equipment and surface system will be installed by a contractor specializing in playground construction.

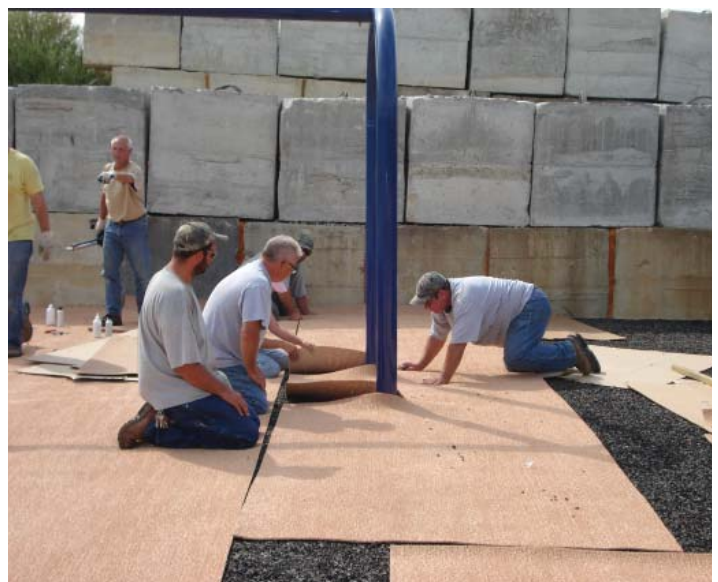
The base layer of crumb rubber has been installed. The top layer, a rubber mat system, is fit around equipment and the seams are joined. Both the equipment and surface system at this site will be installed by the park maintenance crew.

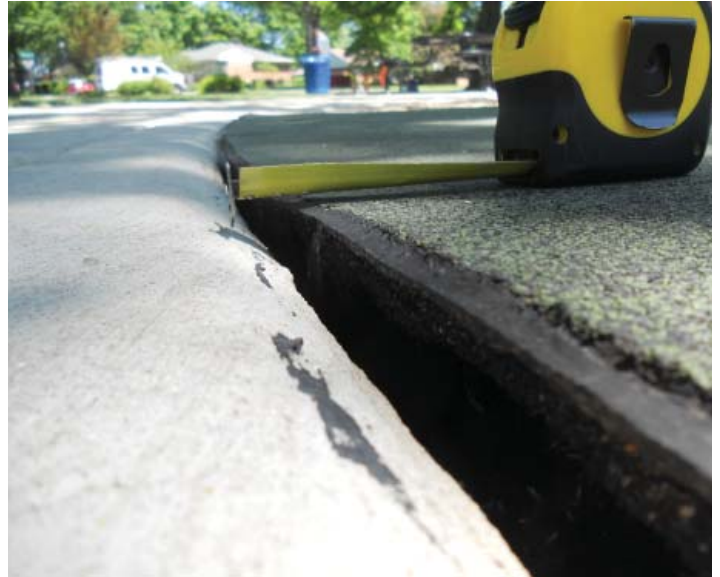
Over time, the unitary surface may separate at the seams or from the border creating gaps, openings or changes in level that will require repair.
