FPL-GTR-155

Stabilized Engineered Wood Fiber for Accessible Trails

Installation and Serviceability Results: Governor Dodge State Park, Wisconsin

Theodore L. Laufenberg

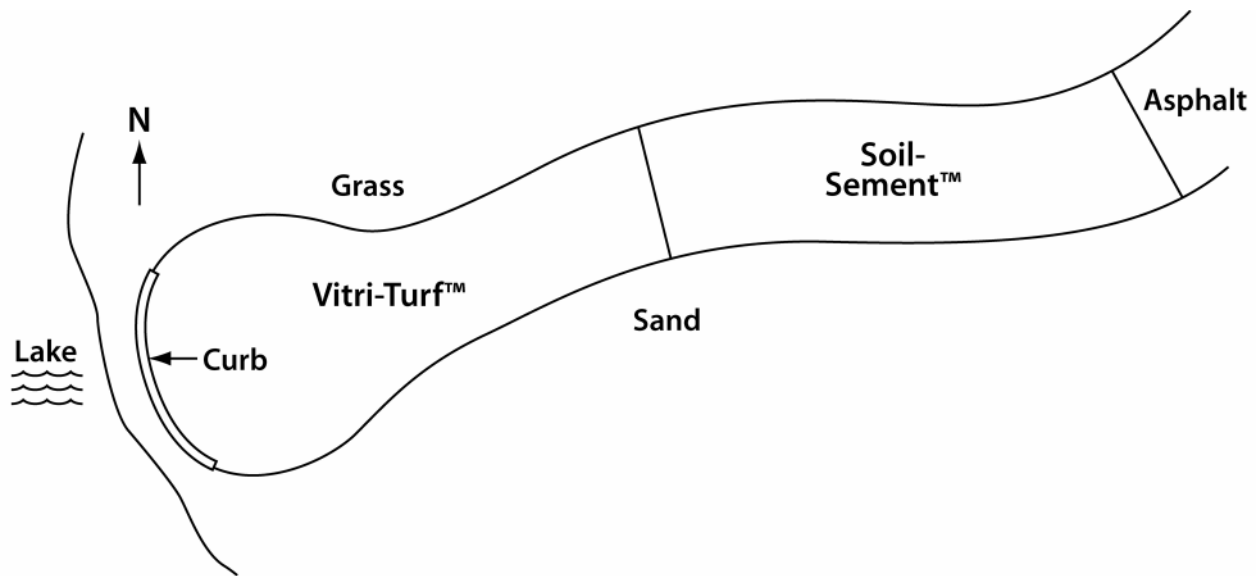
Figure 1—Schematic plan of Governor Dodge State Park Cox Hollow beach path site (not to scale).

Layout of the path across the beach was sloped so that the edge of the path would not hold water. Park personnel were concerned that sand would wash or get kicked over the path surface, which would decrease accessibility and increase maintenance requirements. Slope along the upper edge was a minimum of 1%. Nearer the waterline the slope of the path increased to a maximum of approximately 5% for the final few meters (feet). The amount of waterline fluctuation was considered minimal at this beach because of the proximity of water control structures.

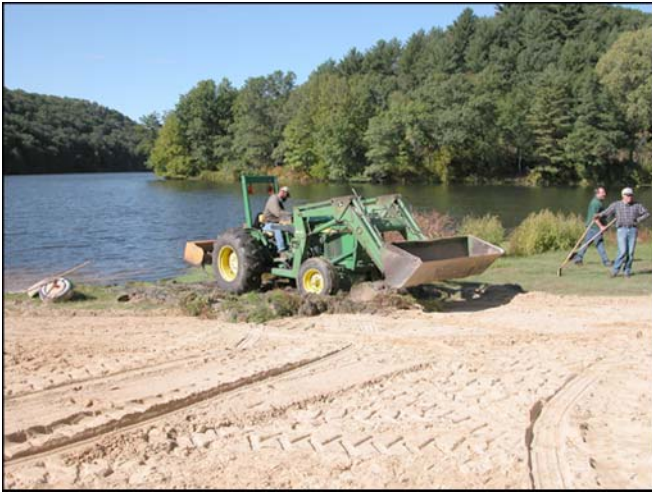
Figure 2—Grading of beach path to waterline.

We first lowered and leveled the existing sand surface to a depth of 0.06 m (2.4 in.) (Fig. 2). Any stones and vegetation near the waterline were removed. Within 1.5 m (5 ft) (horizontal distance) of the waterline, the stability of the sand was deemed inadequate for supporting the SEWF. We removed 0.1 m (4 in.) of sand in this area and replaced it with 20 mm (3/4 in.) of angular stone to provide a well-drained and stable base, which would also reduce the amount of scour from wave action on the lake. The work crew consisted of employees of the park, the Wisconsin Department of Natural Resources, and the USDA Forest Service.

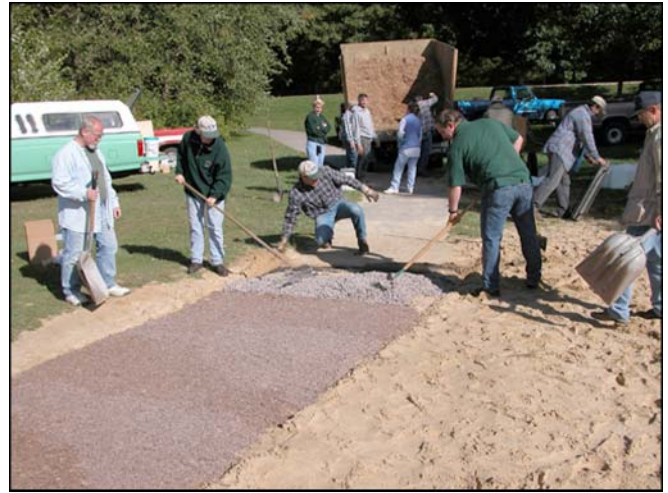
Figure 4—Leveling and compaction of binder-EWF mixture near junction with asphalt path.

5/8-in.) piece of plywood covered with a polyethylene release sheet. A 90-kg (198-lb) person walked on the plywood in each quadrant to apply firm compaction pressure. At the termination of the path at the waterline a 0.1-m (3.5-in.) curb was formed to reduce any inadvertent rolling of the path into the water and to stiffen the edge directly in contact with wave action.

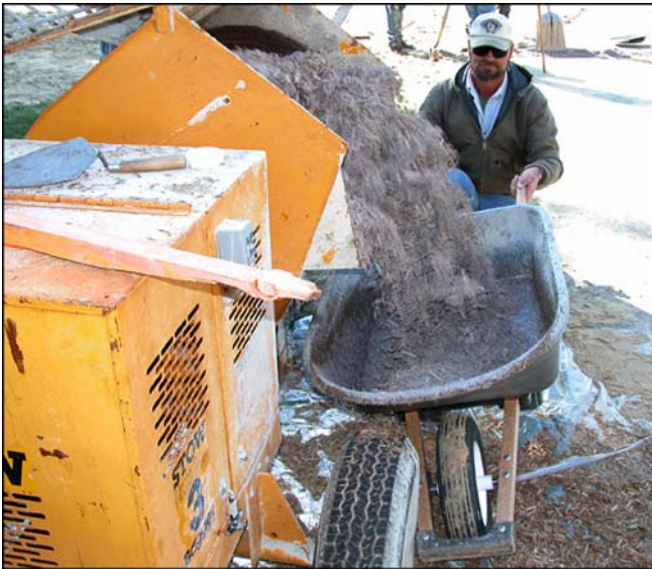
Figure 3—Loading of binder-EWF mixture from mortar mixer into wheelbarrow.

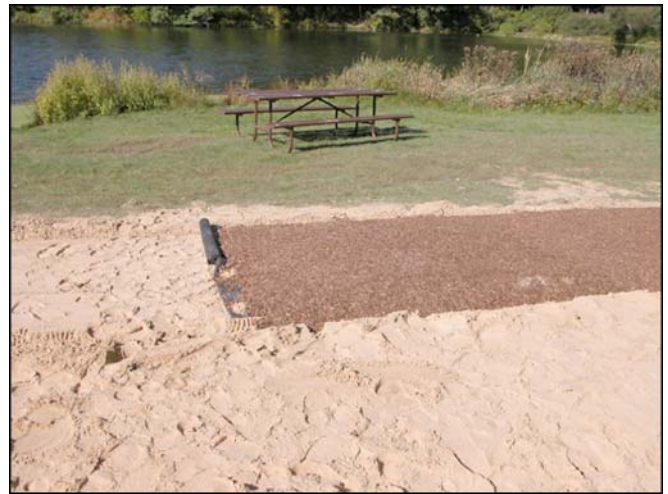
Figure 5—Termination of Soil-Sement portion of beach path. Geotextile fabric visible under completed SEWF surface.

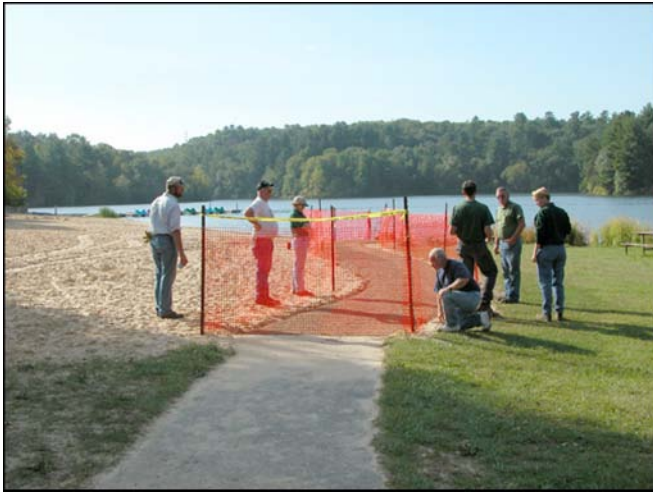
Figure 6—Completed beach path area looking west, shown with temporary barrier for 5-day SEWF curing period.

The two SEWF surfaces were allowed to cure or bond for 5 days prior to use (Fig. 6). Because rain was not predicted, the entire surface was left exposed. Overnight temperatures stayed above 4°C (40°F) for 2 days after installation. Within 2 h of installing the Vitri-Turf, the surface was somewhat rigid to hand pressure. The Soil-Sement surface was slower to stiffen and was deemed stiff within 48 h. Five days after

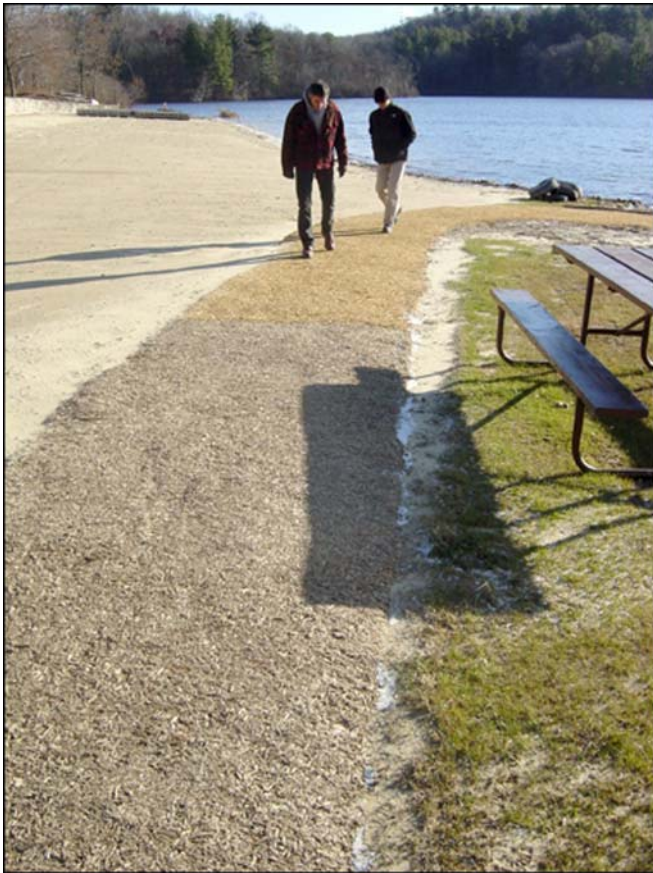
Figure 7—Beach path after 2 months of weathering. Junction of Soil-Sement and Vitri-Turf surfaces is just above the shadow cast by the picnic bench.

installation, the barriers were removed and the edge of the path was backfilled with beach sand using rakes. The completed beach path after 2 months of weathering is shown in Figure 7.

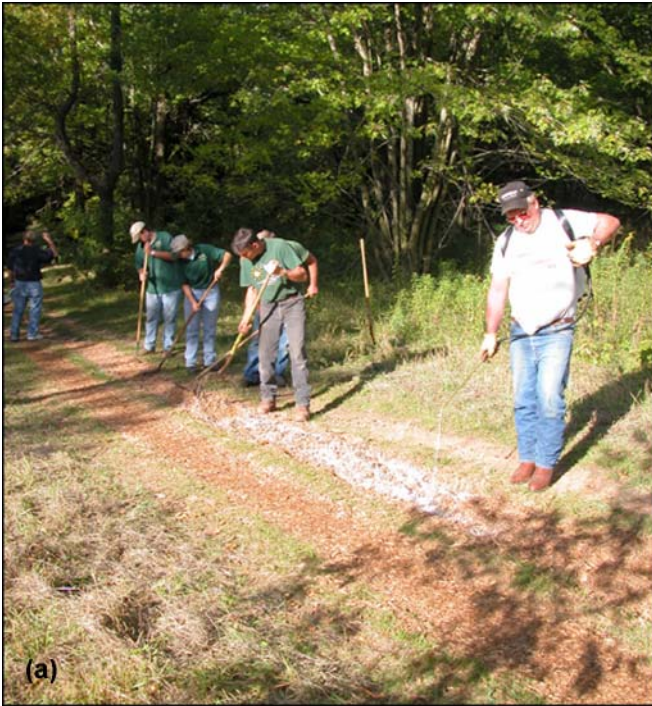
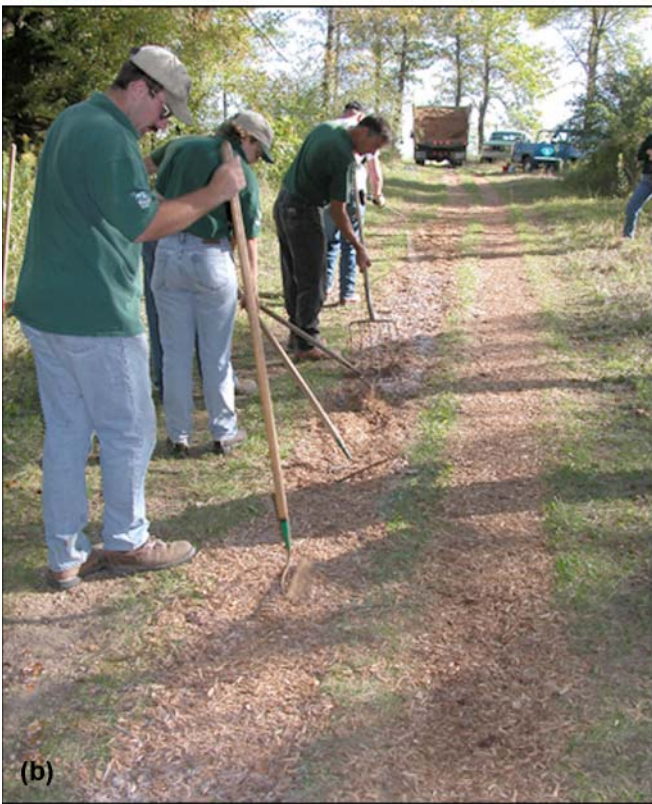
Figure 8—Installation of Soil-Sement surface on bridle path: (a) application of Soil-Sement by backpack-type sprayer; (b) trail crew mixed, leveled, and compacted the narrow trail filled with SEWF.

For both systems, the layer of EWF placed on the soil surface was 0.05 to 0.07 m (2 to 3 in.) deep and was raked smooth. A backpack sprayer and drip-bucket were used to apply the Soil-Sement (approximately 50% solids content) with a target application proportion of 30% binder based on the weight/volume of EWF (Figs. 8 and 9). The Vitri-Turf was much more viscous (100% solids) and thus only a drip bucket approach was used to apply the binder (Fig. 10).

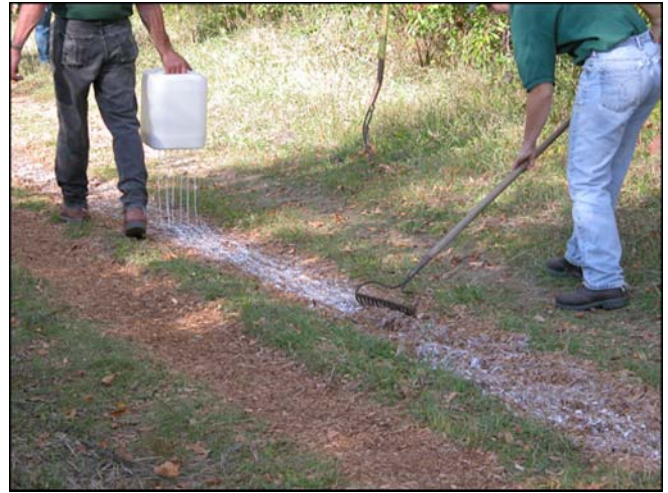
Figure 9—Application of Soil-Sement to bridle trail by drip-bucket method. Rakes were used to mix binder with EWF and level the trail.

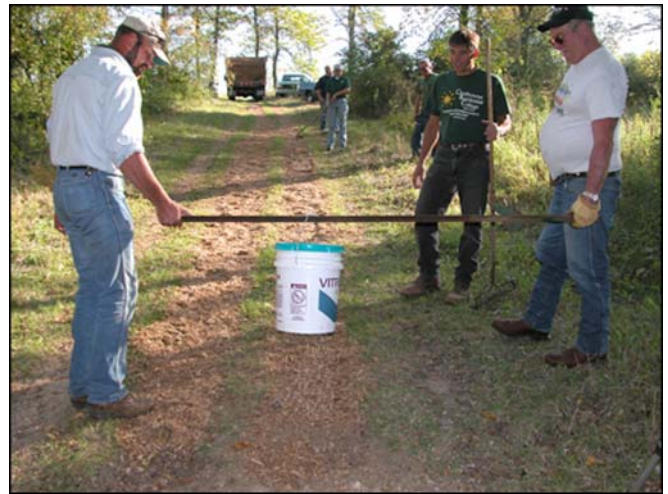
Figure 10—Application of Vitri-Turf to bridle trail by drip-bucket method. Holes drilled in bottom of 19-L (5-gal) container allowed uniform application over 0.4- by 20-m (1.3- by 66-ft) trail.

With a known weight of EWF at an application proportion of 30%, 19 L (5 gal) of binder was applied by moving a perforated bucket (holes 6 mm (0.2 in.) in diameter) quickly over the surface. Immediately after applying the binder, the binder was mixed into the EWF with forks and garden rakes. On the narrow bridle path, the SEWF was compacted using the flat end of a rake. The wider path was compacted using a polyethylene-covered 1.2-m by 1.2-m by 16-mm (4-ft by 4-ft by 5/8-in.) piece of plywood; a 90-kg (198-lb) person walked on the plywood in each quadrant to apply firm compaction pressure (Fig. 11). The SEWF areas were roped off for 5 days to provide time for curing prior to usage.

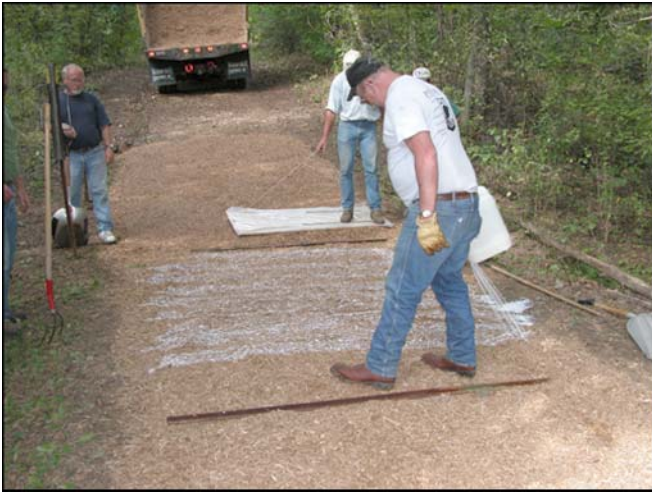
Figure 11—Treatment of wide bridle trail (site 2): spray application of Vitri-Turf in background and drip-bucket application of Soil-Sement in foreground. Note use of polyethylene-covered plywood for compaction and leveling of Vitri-Turf SEWF.

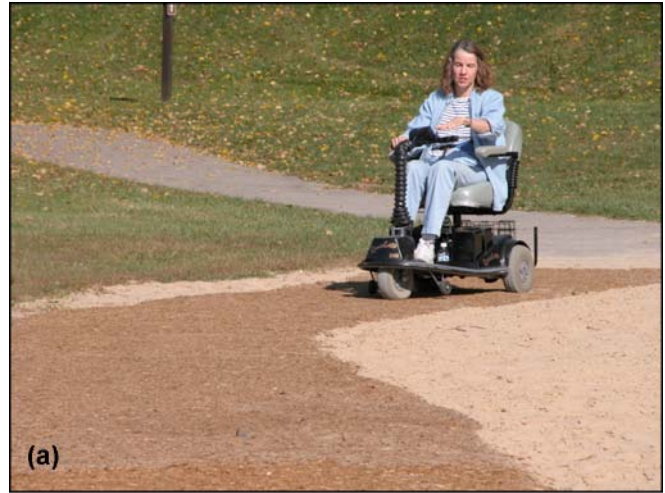
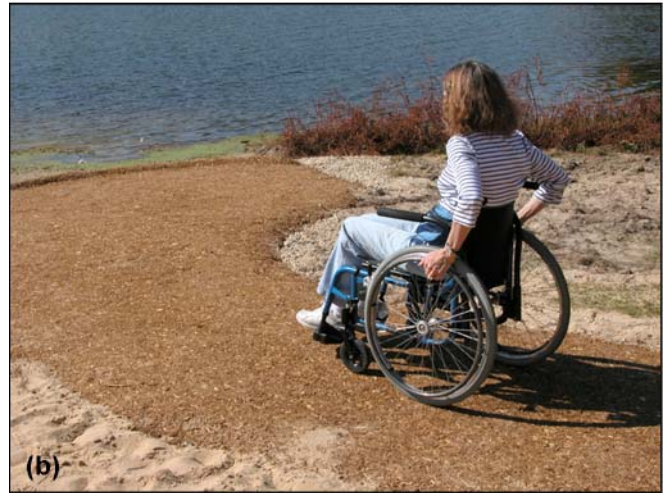
Figure 12—Testing bonded beach path with (a) battery-powered and (b) hand-powered wheelchairs. Shadow near the waterline indicates terminal curb of beach path.

A wheelchair user on the beach path described the Vitri-Turf surface as “nice and firm” and the Soil-Sement surface as “kind of soft” (Fig. 12). Maneuvering the chair was noted to be “easy” on the Vitri-Turf and “not as easy” on the Soil-Sement. The user also noted that the raised curb made her feel comfortable about moving to the end of the path. Without the curb, she felt she would have had to stop a few feet back from the water’s edge.

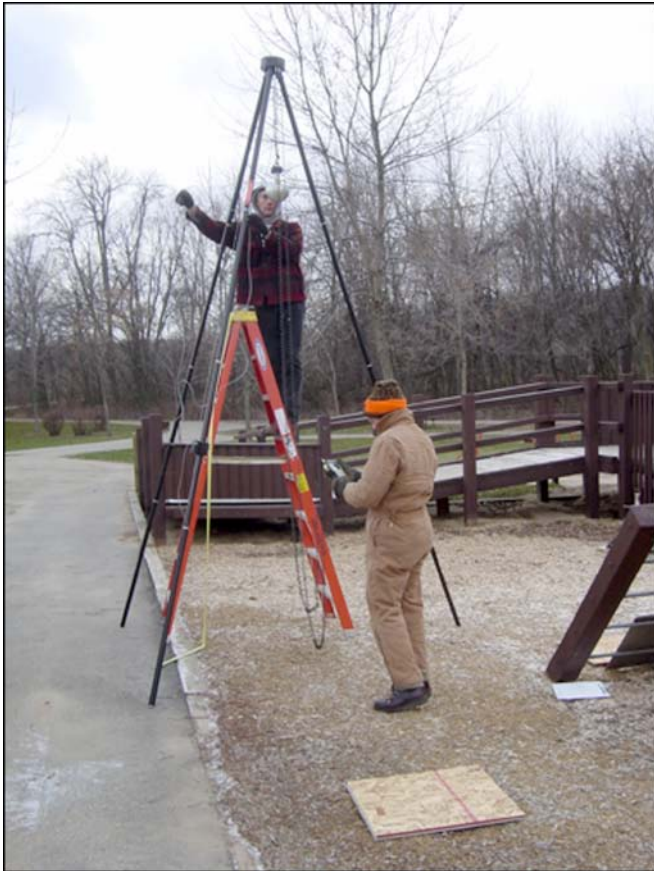
Figure 13—Impact testing on beach path was similar to impact test conducted at a playground using a 3.05-m (10-ft) drop-height.

Impact testing (ASTM F1292, ASTM 1999) of the Vitri-Turf and Soil-Sement surfaces was conducted 8 weeks after installation (Fig. 13).

For the second and third drop tests at 3.05 m (10 ft),

- average *g* readings were 223 for Vitri-Turf and 238 for Soil-Sement and
- average HIC readings were 1679 for Vitri-Turf and 1752 for Soil-Sement.

For the second and third drop tests at 1.82 m (6 ft),

- average *g* readings were 214 for Vitri-Turf and 196 for Soil-Sement and
- average HIC readings were 1370 for Vitri-Turf and 1214 for Soil-Sement.

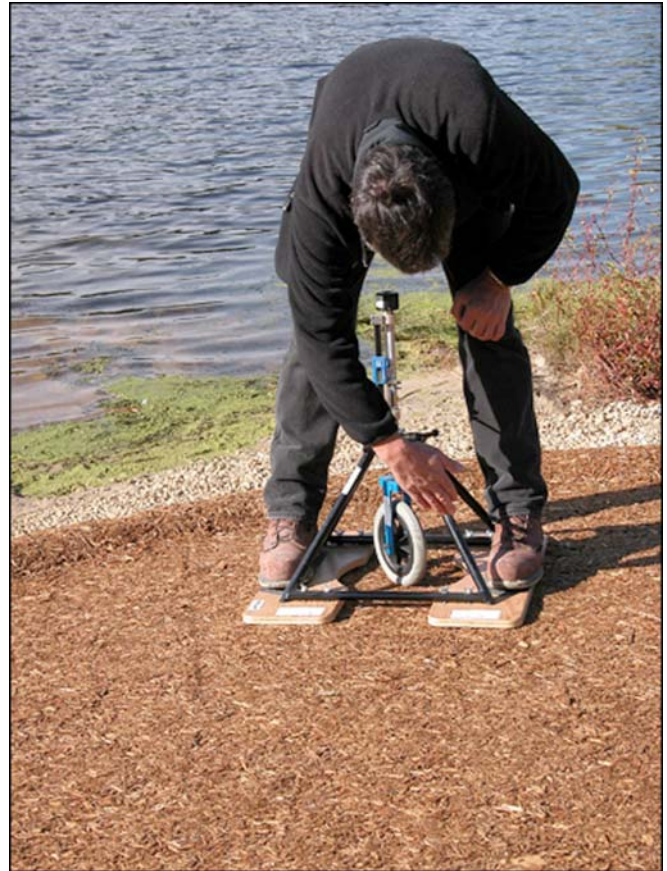
Figure 14—Rotational penetrometer used to measure accessibility.

The beach path surfaces were periodically measured with a rotational penetrometer. This device subjects the test surface to a low-speed rotational bearing test meant to simulate the weight and action of a front caster wheel on a wheelchair. The procedures are based on the draft national standard test method for the firmness and stability of ground and floor surfaces (RESNA 2000), which uses an average of five

During the 10-month period of this testing, the firmness and stability of the SEWF surfaces were measured with the rotational penetrometer (Fig. 14). Both the Vitri-Turf and Soil-Sement showed good performance for accessibility during this period. The Vitri-Turf SEWF indicated “firm” and “stable” during the entire period, with some fluctuation traceable to the changes in moisture with long rainy spells. Soil-Sement SEWF was rated as “moderately firm” and “stable” during the testing period (Figs. 15 and 16).

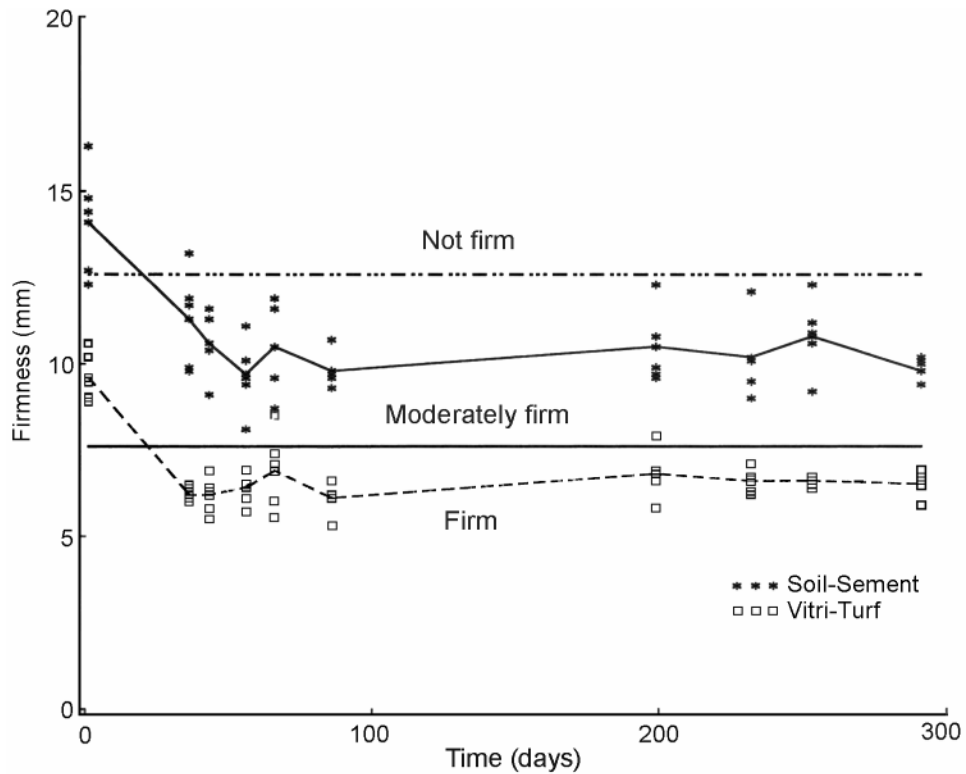
Figure 15—Firmness of Soil-Sement and Vitri-Turf treatments on beach path over first 10 months of installation.

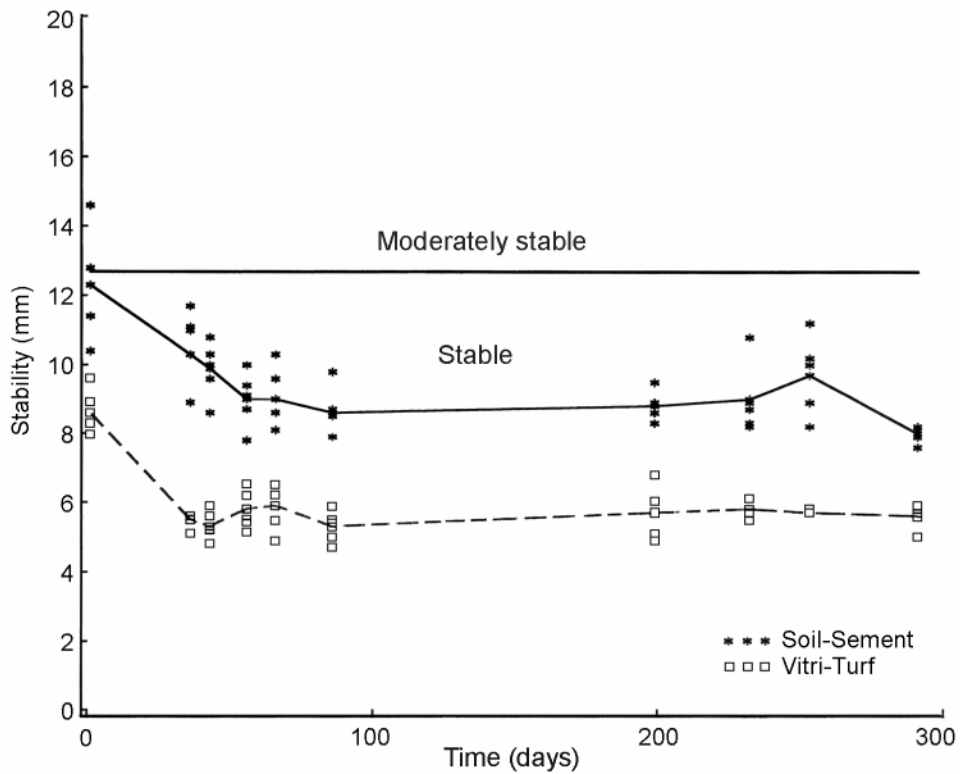
Figure 16—Stability of Soil-Sement and Vitri-Turf treatments on beach path over first 10 months of installation.
