Forest  
Products  
Laboratory

General  
Technical  
Report  
FPL-GTR-138

# Field Performance Testing of Improved Engineered Wood Fiber Surfaces for Accessible Playground Areas

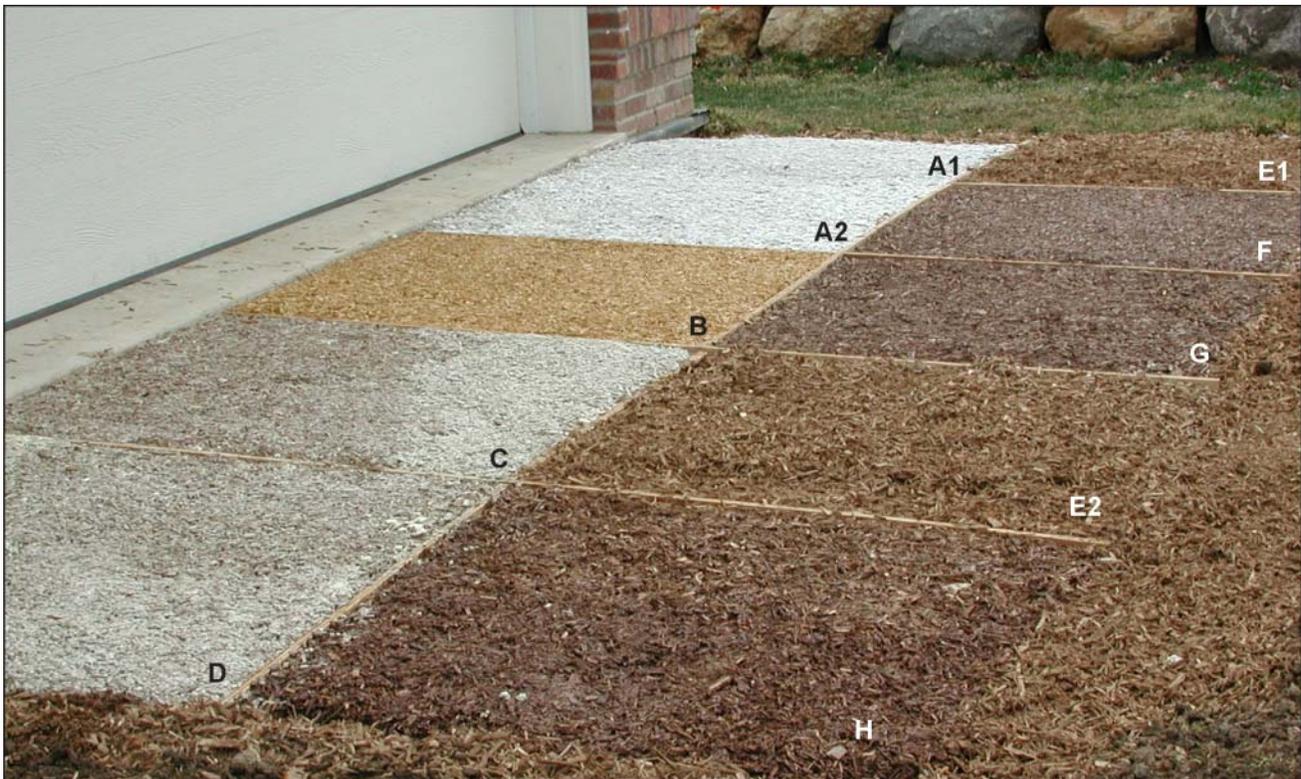
Figure 1—Overview of test surfaces in Madison, Wisconsin. See Table 1.

by 12 in. deep) (Fig. 1). Seven surfaces had a top layer of bonded resin-EWF; one surface served as a full-depth control. In addition, two surfaces (A1 and E1, Fig. 1) were placed on a slope to assure drainage of the entire test surface. All surfaces were made of EWF, as defined by ASTM F2075-01 (ASTM 2001). All test surfaces were compacted to simulate the finished surface of a play area. Because there is no industry, governmental, or association definition or standard for compacting EWF, we followed playground industry installation practices.

<sup>a</sup>Surfaces identified in Figure 1

An interfacial treatment was used for two surfaces (D and G, Table 1, Fig. 1). A 1.2- by 1.2-m (48- by 48-in.) single-ply layer of lightweight polyolefin landscaping geotextile was placed between the unbonded and bonded layers of these surfaces. The geotextile was intended to provide continuity for the thinner bonded surface layers in the event of a fracture through the entire thickness. Should this happen, the layer could be thrust from its original position and become a hazard on the remaining bonded surface.

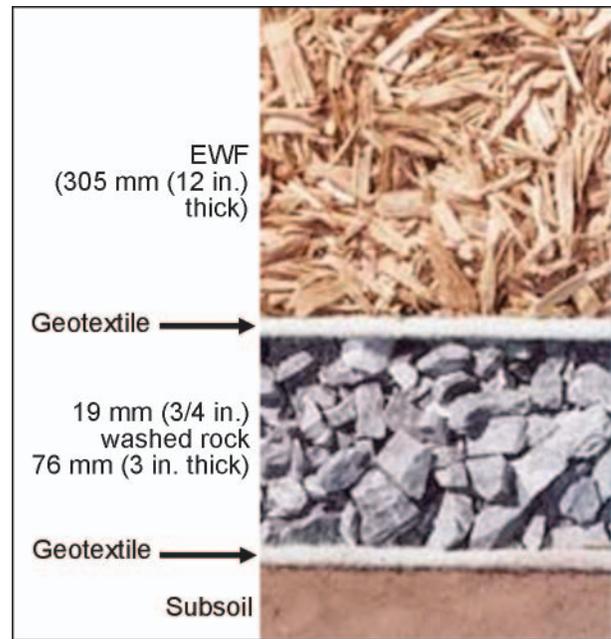
**Figure 2—Representational cross-section of installed surfaces. Note that EWF thickness includes thickness of any stabilized EWF layer.**

In accordance with general EWF design and construction practice, the full-depth surfaces were prepared to the requirements for permanent playground surfaces (Fig. 2). Installation began on February 27, 2002, and surfaces were bonded within 6 weeks. Installation proceeded as follows:

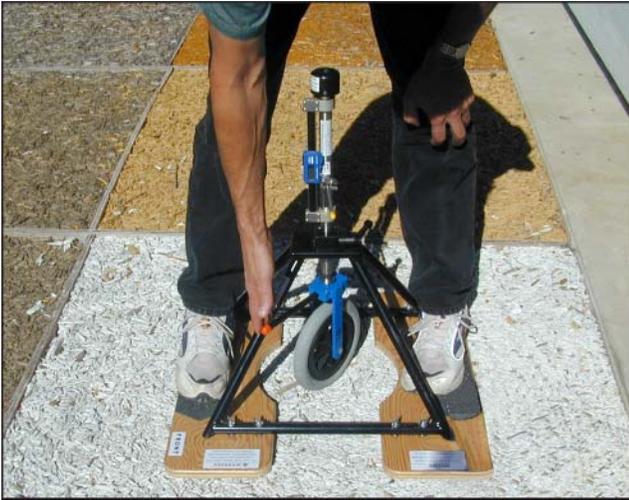
Figure 3—Rotational penetrometer in use on surface A2.

Periodically over the 6-month exposure and again after the 6-month impact tests, all surfaces were tested with a Beneficial Designs rotational penetrometer (Figs. 3 and 4). This device subjects the surface to a low-speed rotational bearing test meant to simulate the weight and action of a front caster wheel on a wheelchair. The procedures used were based on the draft Rehabilitation Engineering and Assistive Technology Society of North America national standard test method for the firmness and stability of ground and floor surfaces (RESNA 2000), with the exception that only one reading was recorded instead of the average of five readings. This test provides objective measures of firmness and stability of surfaces. It has been correlated to the work measurement done in ASTM F1951 (ASTM 1999b) for a wide array of surfacing and floor coverings. The test was conducted 1 week after surface installation and each month thereafter using the rotational penetrometer and protocol for assessing the bearing/rotational indentation on each surface (Axelson and Chesney 1999). Each surface was tested at a unique location around its periphery.

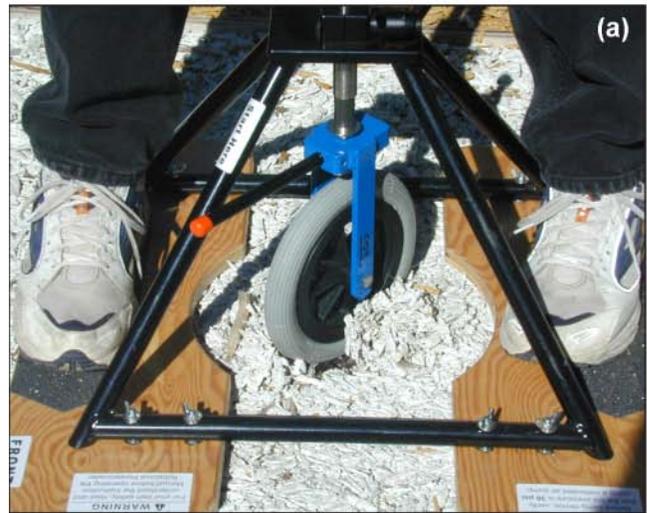
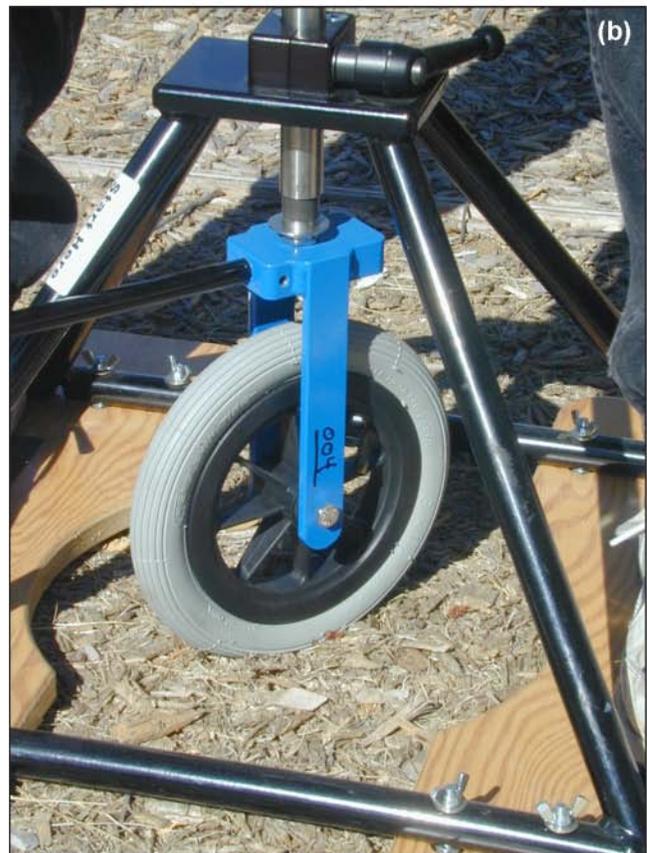
Figure 4—Accessibility test with rotational penetrometer. Stability readings taken after caster wheel was rotated 360°. (a) Poor stability of surface A2 indicated by amount of silicone-coated EWF displaced by rotated caster wheel; (b) good stability of surface G.

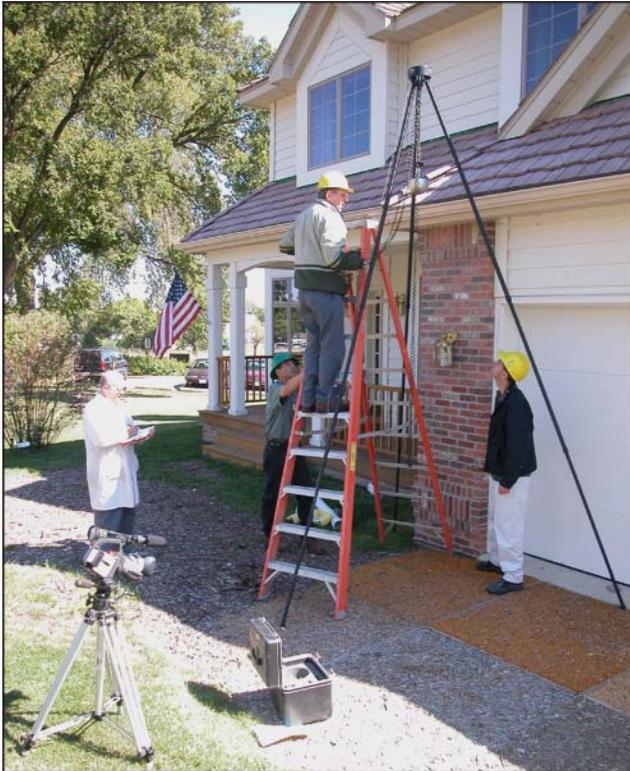
**Figure 5—Impact attenuation test. A 4.5-kg (10-lb) hemispherical impact head was installed 3 m (10 ft) over surface D. Ted Illjes (on ladder) holds instrumentation package connected to impactor by coiled wire. Doug Zeager awaits arrival of impactor, which will be caught on first rebound from surface.**

Impact tests were conducted by Doug Zeager and Ted Iljes of Zeager Brothers, Inc. (Middletown, Pennsylvania). The impact test was completed after the test surfaces had been exposed for 6 months. ASTM F 1292–99 (ASTM 1999a) test specifications and F355–95 (ASTM 1995) test methods were used at a constant test drop height of 3.05 m (10.0 ft). Three impact tests per test surface were run in sequence according to the specifications. A tripod was erected to center the impactor over each test surface (Fig. 5). Per ASTM F355, the instrumented headform was mounted on a magnetic release over the center of the surface.

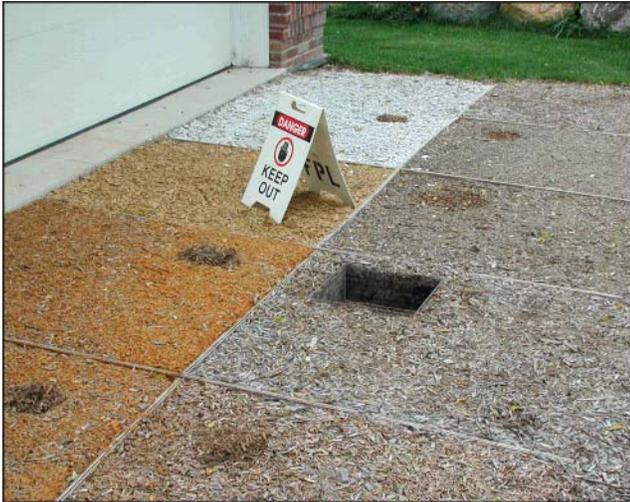
**Figure 6—Removal of test sample for determination of density and moisture content of surface layer and EWF beneath surface.**

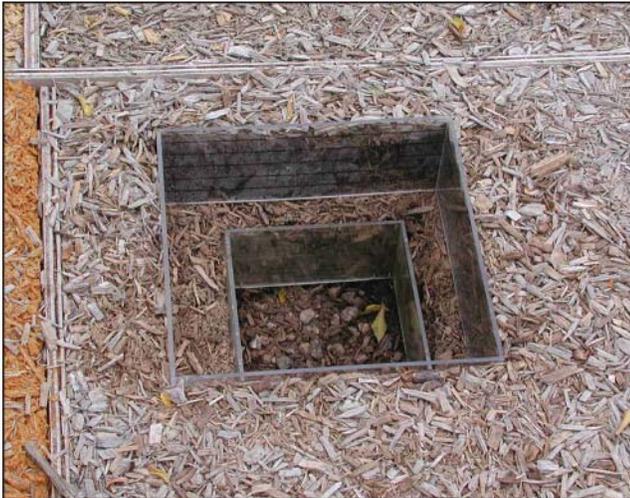
**Figure 7—Archeological-type excavation for determining moisture profile of E2 surface. Note gravel at bottom of 0.3-m (12-in.) excavation.**

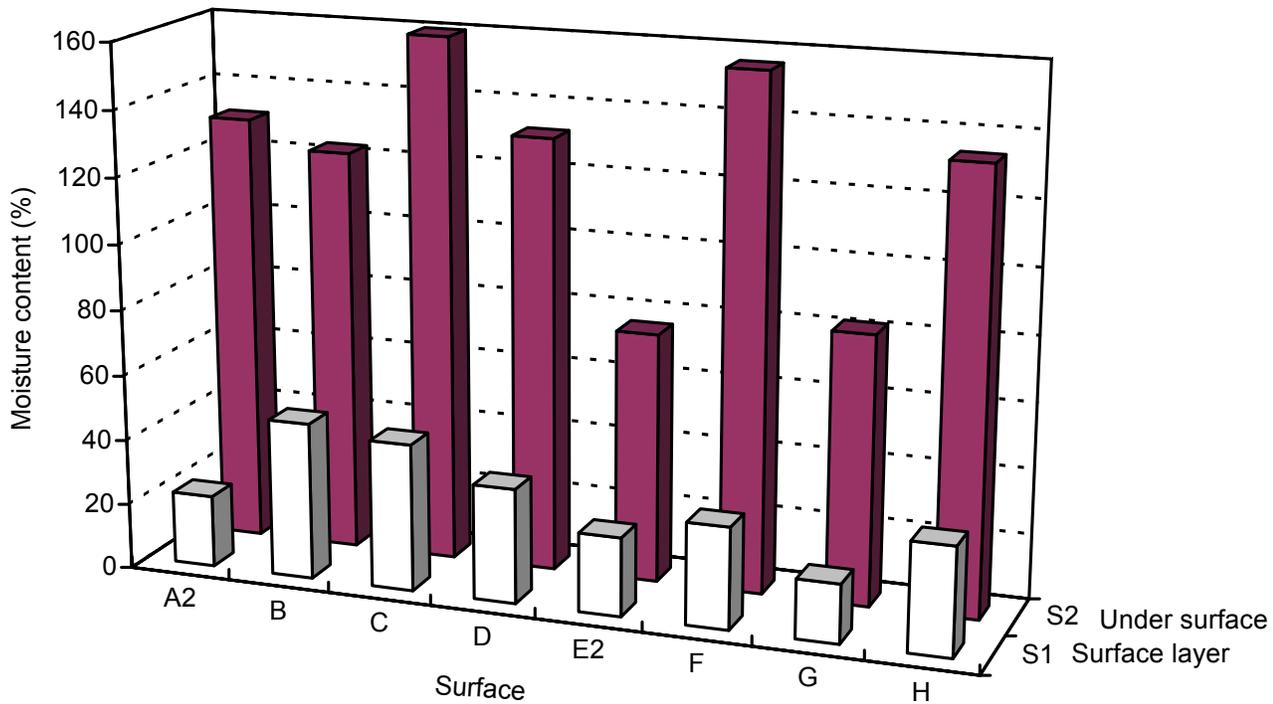
**Figure 8—Comparison of average moisture content of stabilized surface layers with moisture content of EWF immediately beneath surface.**

Because of the in-situ nature of the tests and the size of the test surfaces, we did not have a means for nondestructively evaluating moisture content or durability of these surfacing systems. Thus, we relied on visual evaluation of the surfaces during the 6-month exposure period; moisture content samples were removed after the test period (Figs. 6 and 7). Data on surface layer density and moisture content and EWF moisture content just beneath the surface layer are shown in Table 5 and Figure 8.

Moisture content measurements indicated that the bonded surface layers, on average, were not as wet (by weight) as the E2 surface (unstabilized EWF). The measurement of moisture content is misleading because of the nonhygroscopic properties of the binder. However, the EWF under the stabilized surfaces was wetter than the bonded surface layers. This suggests that the EWF–resin surface layer retarded the drying process, which, in turn, saturated the underlying EWF.

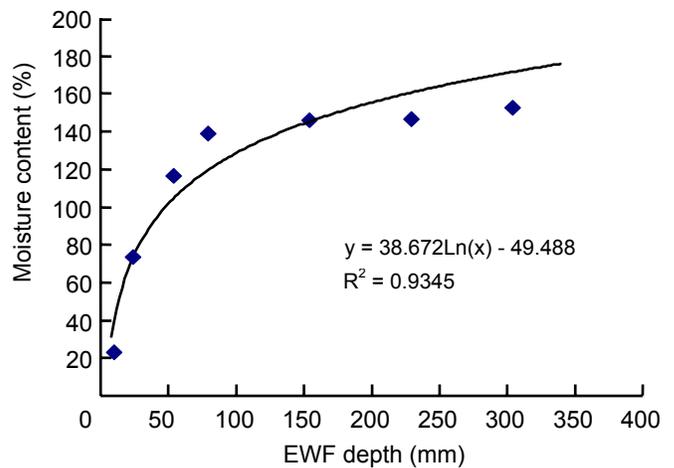
**Figure 9—Profile of moisture content through EWF of surface E2 and trendline fitted through measurements.**

Another representation of EWF moisture content is shown in Table 6 and Figure 9. The trendline fitted to the data of the E2 moisture profile (Fig. 9) indicates that saturation occurred at a depth of approximately 100 mm (4 in.) and continued to the drainage bed. Additional study would yield knowledge of the rate of decay under these very wet/ saturated conditions. We have no quantified model for predicting the loss (decay) of woody material under these moisture conditions. We could easily presume that the development of a stabilized resin–EWF system with reduced moisture content in the unbound EWF would result in a beneficial reduction of decay rate. This, in turn, would extend the life of stabilized EWF in situ on playground surfaces.
